NASA Technical Memorandum 103242
AIAA-90-2586

Requirements for Long-Life Operation of Inert Gas Hollow Cathodes— Preliminary Report

Prepared for the
21st International Electric Propulsion Conference
cosponsored by the AIAA, DGLR, and JSASS
Orlando, Florida, July 18-20, 1990

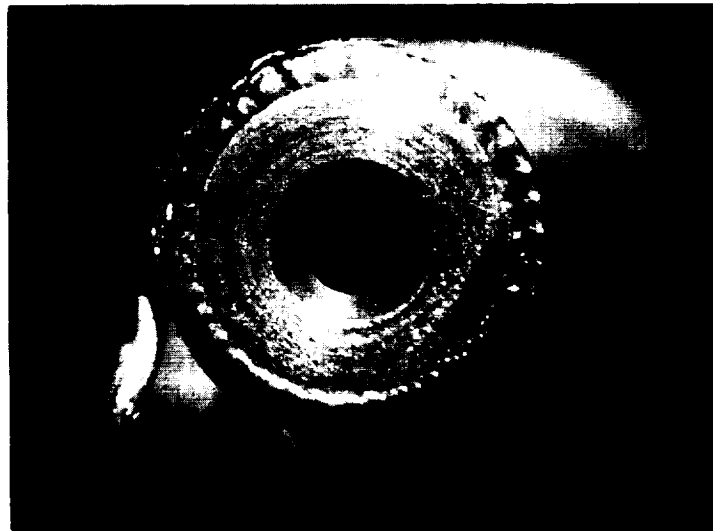
Figure 10. Condition of the hollow cathode orifice plate. Photo a. is of a cathode orifice plate with no operational time. Photo b. is the orifice plate after the 500 hour wear test.

Fig. 10 shows the orifice plate before and after the test. From the figure, it can be seen that substantial texturing of the orifice plate had occurred. It was also found that, over the course of the test, the ignitor electrode had sagged and begun to intercept the cathode plume on one side. Substantial erosion of the ignitor electrode occurred, leading to deposition of the electrode material over the surfaces of the simulator chamber.
